Manhole Inspection Summary

Manhole # S35U__028MH

Location Address: **1442 marshall st**

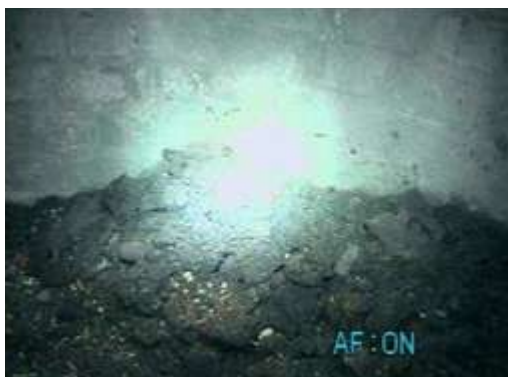
Defect 1

Condition: ☐ Sound ☐ Cracked ☐ Root Intrusion ☐ Deteriorated ☐ Leaks ☒ **Debris**

channel debris

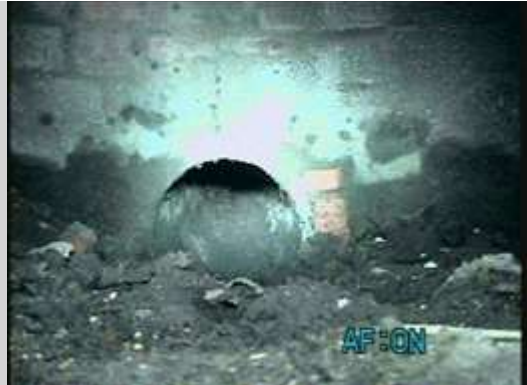
12 O'Clock Outflow

8 in. Circular Gravity Sewer
Pipe Out @ 12 O'Clock

Deposits: ☐ None ☒ **Mud** ☐ Sludge ☒ **Debris** ☐ Grease

Silt Depth: **2** (in.) Deposits Extent: **Medium**
